# Analysis of Temperature Variations, Types of Insulation and Coating on Corrosion Under Insulation on ASTM A53 Pipes

Reza Putra\*, Muhammad, T Hafli, Nurul Islami, Arpan Apandi S

Department of Mechanical Engineering, Faculty of Engineering, Universitas Malikussaleh, Aceh, Indonesia

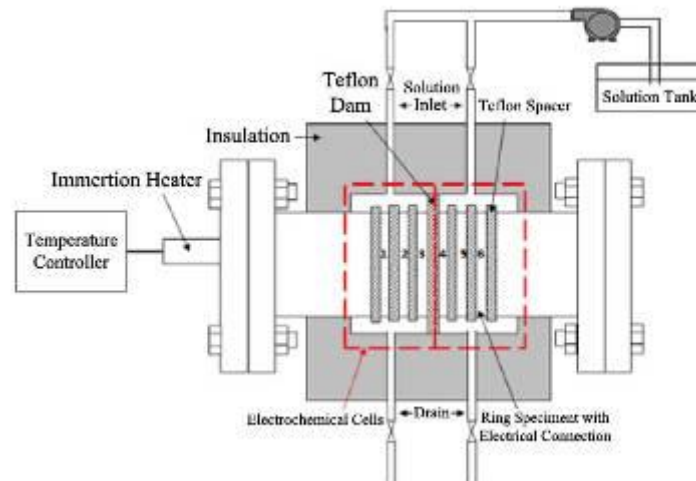
Fig 1. CUI Simulation Cell Schematic [13].

Corrosion testing standards under insulation can be found in ASTM with the revision number G189 in 2007. This ASTM standard is the official guide for laboratory corrosion testing under insulation. These guidelines are generalized and can be carried out with variations in specifications in various materials, environments, and conditions depending on the desired experiment. However, there is limited research or implementation of this test using ASTM G189-07, and the analysis is generally limited to getting the corrosion rate only [16]. Thus, in this paper, ASTM G189-07 was applied to obtain the most influential factors in the incidence of CUI (Figure 1).

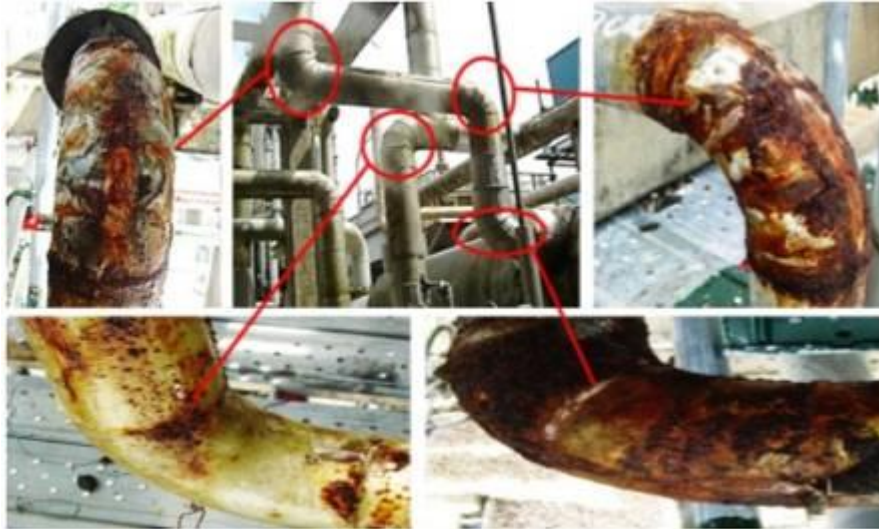
Fig 2. Corrosion Under Insulations [19]

Corrosion under insulation refers to the external corrosion of piping and vessels made of carbon-manganese, low alloy, and austenitic stainless steels that occur under the outer layer or jacketed insulation due to water penetration. Due to its nature, CUI tends to remain undetected until the coating insulation is removed to allow inspection or when a leak to the atmosphere occurs. CUI is a major common problem worldwide occurring in all refining, petrochemical, power, industrial, onshore and offshore industries. This is not a new problem, but it could be a serious problem. CUI has been responsible for many major leaks leading to health and safety incidents, resulting in production losses, and is responsible for the large maintenance budget required to mitigate these problems. Figure 2. shows the condition of the pipe corroded under insulation [21].

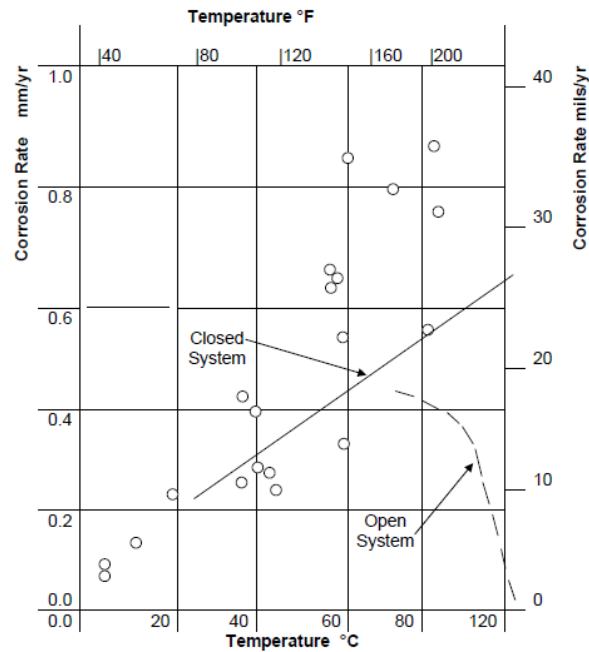
Fig 3. The graph of the relationship between corrosion rate and temperature.

Figure 3. It can be seen that the relationship between the corrosion rate and temperature, the difference that occurs is more focused on the difference in the system, namely an open and closed system. To make it more clear, see the explanation below:

In this system, it is known that with increasing temperature, the corrosion rate will also increase but eventually it will decrease again. In this event, the remaining water will evaporate so that in the water system nothing is trapped.

In contrast to a closed system, this system when the temperature increases, the corrosion rate increases or it can be said that the corrosion rate is proportional to the temperature. Because in this event the water is trapped in the system at the same time it cannot evaporate completely.

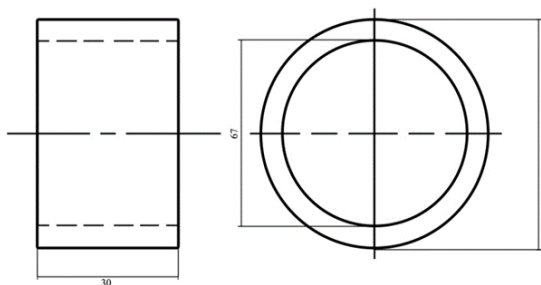
**Fig 4.** Pipe Dimensions

Simple drawings for the dimensions of this pipe can be seen in Figure 4. and Figure 5. as follows.

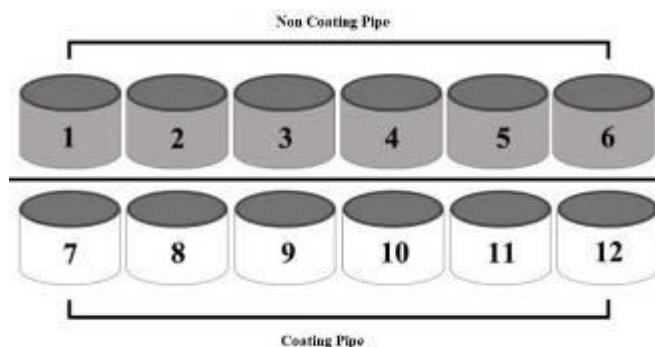
**Fig 5.** Pipe preparation with and without coating

ASTM A53 steel pipe was cut into test specimens with a width of 30 mm using a band saw. The 12 piece test specimens were cleaned thoroughly according to ASTM G1-03. In this test, a comparison is made between the coated and uncoated test specimens. Coating of specimens using paint with Meiji Epoxy Filler paint. The painting was done using a spray gun at a distance of 25 - 30 cm and a speed of 25 - 40 cm/second from the surface of the specimen. In this test the thickness of the coating ranged from 290 m – 410 m refer to ASTM D 1186. The results of the measurement of paint thickness after drying were carried out according to the standard ASTM D 1005. Some of the test specimens were installed with Rockwool insulation and the other half were fitted with glasswool with the same area and length as the specimen. All test specimens that have been insulated are coated with aluminum as packaging.

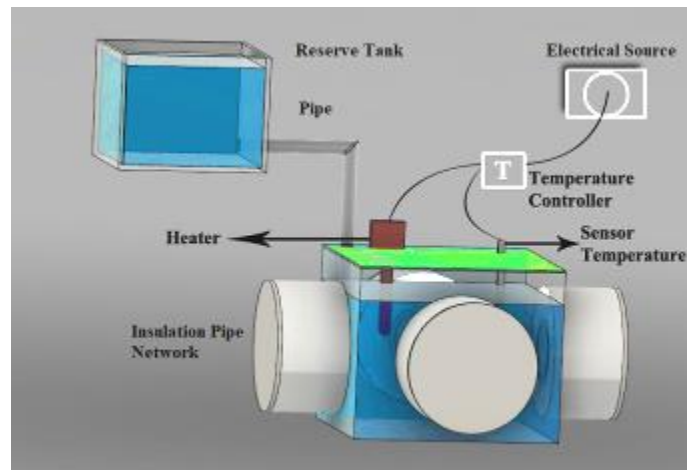
Fig 6. The design of the experimental circuit

This Corrosion Under Insulation study uses the ASTM G189-07 Standard. This standard is applied to obtain the most influential factors in the incidence of CUI, namely the type of material, the influence of temperature, environment, and certain conditions, depending on the desired experiment. The pipe-shaped test specimens were grouped into 3 variations of the internal temperature test of the water fluid in the pipe, namely 30, 50, and 70°C. The test equipment for each temperature variation has four specimens. Of the four specimens, they were divided into two with Rockwool and Glasswool insulation types, in each type of insulation there were coated and non-coated specimens. In the test box, the water fluid is heated according to temperature variations with the help of a heater and thermostat controller so that the temperature in the test box remains constant. The water fluid in the reserve tank is also prepared to have flowed through the hose to the circuit box (Figure 6.). This insulation is conditioned in a wet state by providing drops of water with a pH value of 4.

The series of tests were carried out for 336 hours so that the research did not take a long time because this research method was used for laboratory corrosion experiments under insulation. Every 6 hours the insulation is moistened with 2 ml of water to keep it moist so that corrosion continues. After 336 hours the test circuit is dismantled and the pipe condition should be as it was when the initial weighing was carried out.

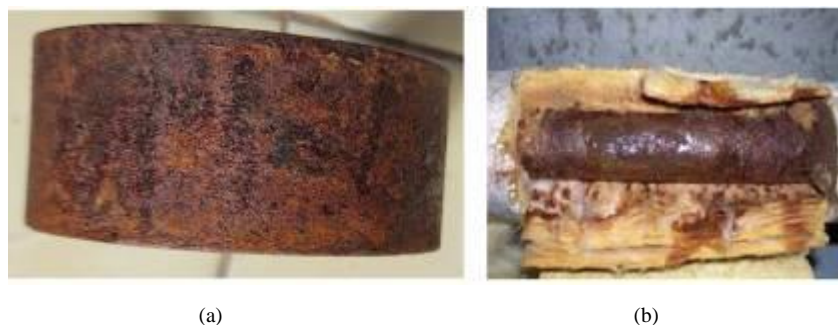
Fig 7. Corroded pipe under uniform corrosion type insulation (a) Result of research ; (b) Sulardi Research [26]

The results of the research obtained after it was carried out showed that the type of corrosion was evenly distributed. This type of corrosion occurs evenly on the outer surface of the pipe which is coated with insulation, this type of corrosion can occur due to electrochemical reactions and low pH of water and moist air due to the outer surface of the pipe. Seawater used as a corrosive medium has a pH value of 4 and belongs to the acid category. Figure 7 shows the difference in uniform corrosion of corroded pipes under insulation.

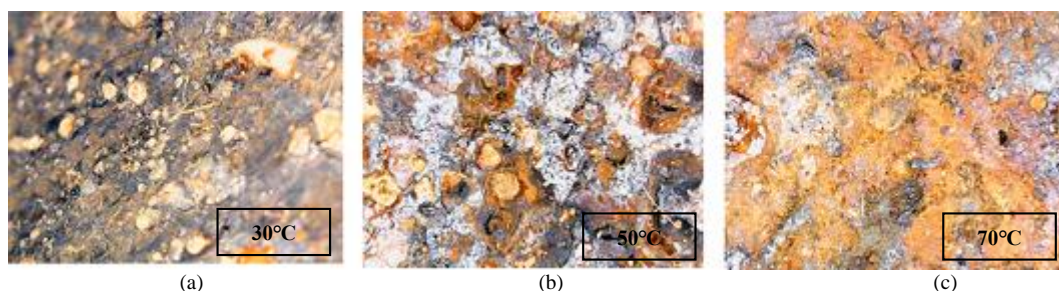
Fig 8. 100x magnification of a glasswool-insulated non-coated pipe (a), (b) and (c) uniform corrosion.

Figure 8. (a), (b), and (c) show that the three images are the results of the 336-hour test on the ASTM A53 pipe which is insulated with Glasswool at temperatures of 30°C, 50°C, and 70°C non-coating. The type of Uniform Corrosion can be well-identified because of its comprehensive and uniform attack appearance on all metal surfaces. This corrosion occurs if the corrosive environment has equal access to all parts of the metal surface and the metal must have the same chemical composition thermodynamically. However, this condition does not generally apply. In general, this uniform corrosion does not have good self-protective properties, so that the corrosion mechanism in all places proceeds without significant obstacles.

The outer surface of the carbon steel pipe was examined using a 100x Digital Microscope camera to see and observe the shape of the corrosion. The following are the results of micro photos on non-coated and coated Glasswool material. Figure 8. below is the result of observations on pictures of non-coating pipes that are insulated with glasswool.

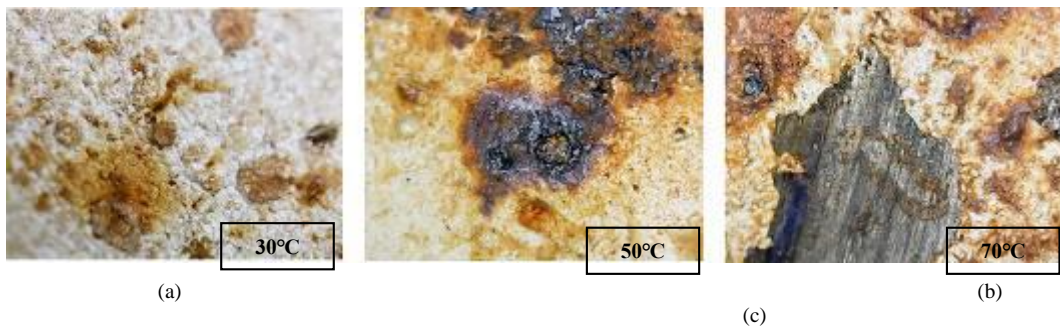
**Fig 9.** 100x magnification of the pipe in the Glasswool insulated coating  
(a) Corrosion products; (b) uniform corrosion; (c) Peeling off the coating

In Figure 9 (a), the test specimen with a temperature of 30°C shows the appearance of corrosion products on the pipe surface, which is a common type of uniform corrosion that occurs on metal surfaces. Figure b) 50°C shows that uniform corrosion occurs but the growth is more. Corrosion occurs simultaneously on the entire metal surface, therefore the metal that undergoes corrosion evenly will experience a relatively large reduction in dimensions per unit time. Figure c) 70°C shows that the result of high water temperature causes damage to the coating layer so that the corrosion that occurs in the pipe goes directly to the outer surface layer of the pipe, causing an abnormal corrosion rate.

The results of the observations on the picture of the pipe in the glasswool insulated coating are shown in Figure 9.

In pipe specimens carried out during testing with coating treatment, there is still corrosion that occurs even though the corrosion rate is still much lower than non-coated pipes. This is because there is still damage that occurs in the coating layer.

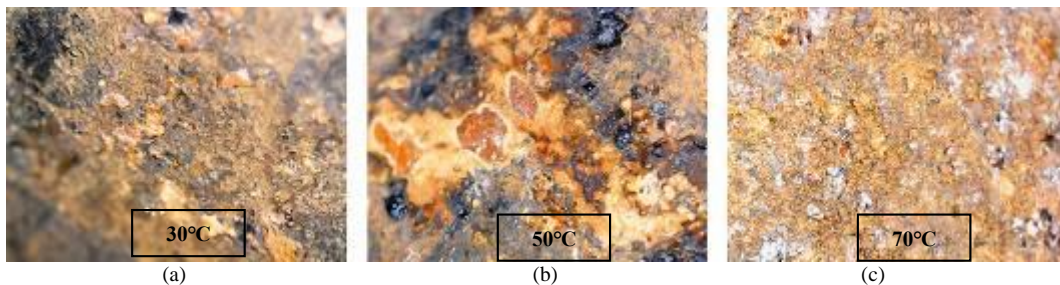
**Fig 10.** Observation with 100x magnification on non-coated pipe insulated Rockwool  
(a), (b) and (c) uniform corrosion.

Based on the characteristics of the damage in Figure 10, namely, Figure a) 30°C indicates that the type of corrosion that occurs is uniform corrosion with the same intensity. In picture b) 50°C above also still shows the type of uniform corrosion. Uniform corrosion occurs as a result of a chemical reaction due to the low pH of the water and the moist air on the specimen surface. In Figure c) 70°C, it can be seen that the type of corrosion that occurs is uniform corrosion with uniform size, this is due to the anodic and cathodic processes that take place on the pipe surface that moves evenly. the influence of a wet insulation environment causes the outer surface of the pipe to be susceptible to corrosion.

The results of observations on non-coating pipes that are insulated with rockwool are shown in Figure 10.

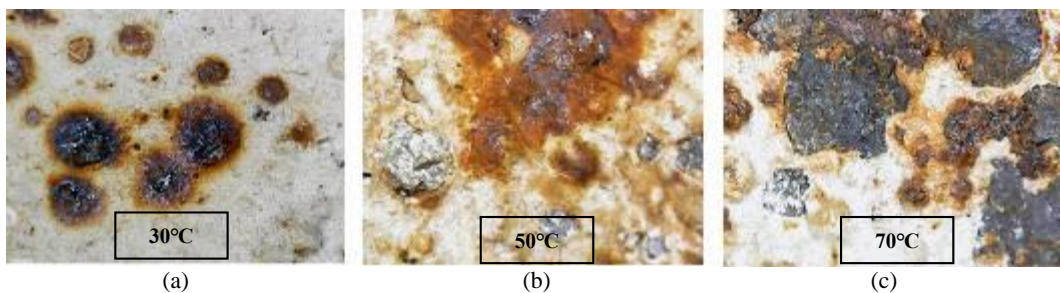
**Fig 11.** Observations of 100x magnification on the pipe in the Rockwool insulated coating  
(a) corrosion products; (b) uniform corrosion; (c) peeling off the coating

Figure 11, which is in Figure a) 30°C shows the occurrence of uniform corrosion were in this case what is happening is still forming corrosion products or the initial process of uniform corrosion. In figure b) 50°C shows uniform corrosion on the outer surface of the coated pipe. And at c) 70°C indicates that there is peeling of the coating on some of the outer surface of the pipe, this is because the nature of the coating will fail if the coating is under stress. Stress is meant here not only from the physical form of mechanics that can cause deformation. Anything that can degrade or attack the integrity of the coating can also be called stress.

Observation of the pipe in the Rockwool insulated coating after the corrosion test is carried out is shown in Figure 11.

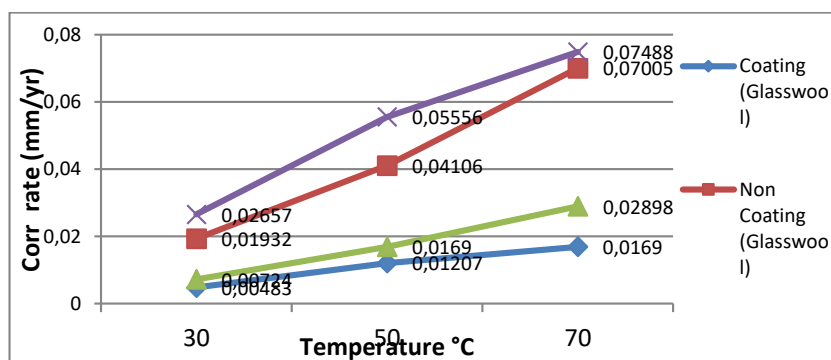
Fig 12. The corrosion rate of ASTM A53 pipe insulated with Glasswool and Rockwool

The graph in Figure 12. Shows the comparison of test specimens using two types of insulation, namely Glasswool and Rock-wool, with temperature variations of 30°C, 50°C, and 70°C. This graph also represents the average value of the test specimens that have been coated or not. The graph shows the highest corrosion rate occurs in the type of Rockwool insulation at each temperature of each non-coated specimen. This is because the type of Rockwool insulation used has a high water absorption capacity so that the water in the initial layer of insulation is directly absorbed into the pipe surface layer. The corrosion rate of pipes coated with different types of insulation, Rockwool, and glasswool, showed a significant difference at a temperature of 70°C with a corrosion rate of 0.07488 mmpy for non-coated rockwool insulation when compared to non-coated glass-wool at the same temperature, of 0.07005. mpy. The results of this weightloss study prove the NACE International theory which states that for every increase in temperature that occurs at 15°C to 20°C (27°F to 36°F), the corrosion rate will increase twice as much as before. The maximum ability to corrosion generally lies between these two averages. The lowest corrosion rate occurred in specimens coated with glasswool at a temperature of 30°C at 0.00483 mmpy. This value was 0.241% lower than the specimens coated with rockwool coating.

that occurs. The method used is by conducting a research period to get the value of weight loss due to corrosion that occurs. The results of the calculation of the corrosion rate in each variation, a graph is obtained that shows the correlation between each temperature variation and the variation of the type of insulation.

Based on the results of research that has been carried out for 336 hours, it shows that the corrosion rate can be entered into 2 parts, namely outstanding and excellent. The outstanding part is the entire temperature for the coated glasswool insulation and the 30°C and 50°C temperatures for the coated rockwool insulation. The excellent part is the entire temperature of the non-coated glasswool and rockwool insulation and the temperature of 70°C for the coated rockwool insulation.
